Technical Report REMR-OM-18
June 1997

REMR Management Systems—Navigation Structures, Condition Rating Procedures for Roller Dam Gates

by *Lowell F. Greimann, James H. Stecker, and Timothy A. Kraal*
Department of Civil and Construction Engineering
Iowa State University

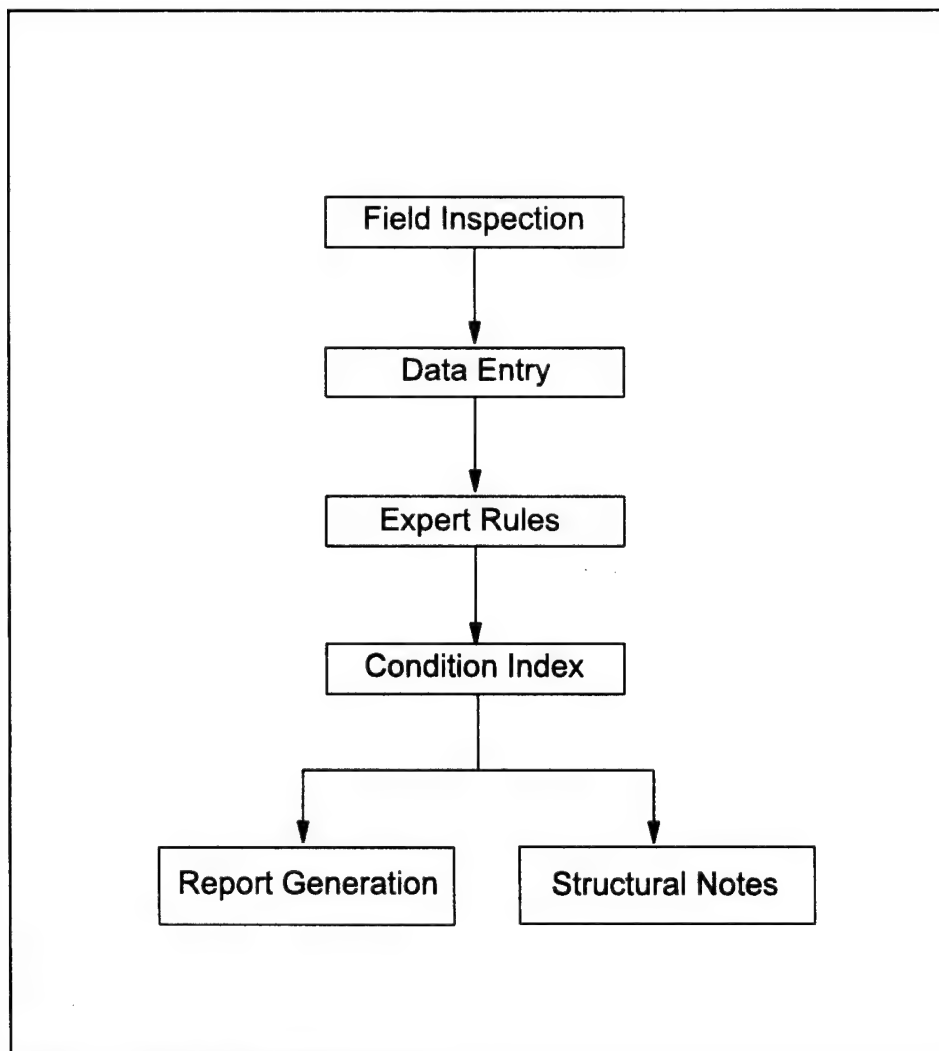
Figure 1. Inspection and rating procedure

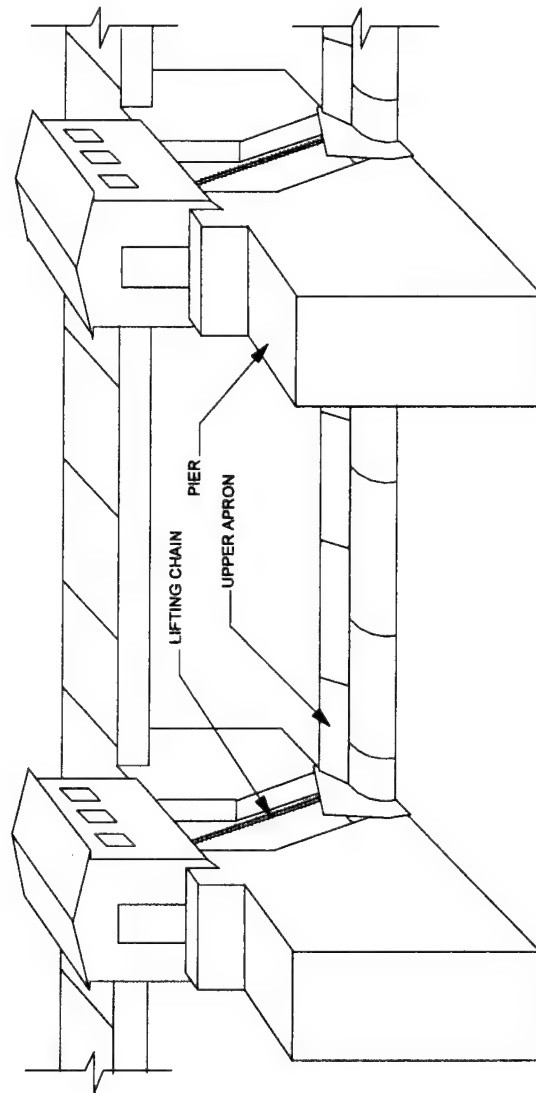
Figure 2. Roller dam (double-apron submersible gates)

Roller dam gates are used to control the upper pool elevation at a lock and dam structure. The basic purpose of a roller gate is to control the amount of water that flows from the upper pool to the lower pool. This is accomplished by lifting or lowering the roller gate to suitable elevations. A lifting chain attached to one end of the roller gate forces the gate to roll up an inclined rack attached to the pier. To lower the gate, the lifting chain is let out and the gate rolls down the inclined rack into the river. Openings in the gate skin plate allow the gate to fill with water so that it does not become buoyant. Figure 2 is an overall view of a submersible roller dam gate.

Upper apron: Many submersible gates have an apron on top of the drum called an upper apron. The upper apron prevents flow over the top of the roller gate when the gate is in the closed position. When a gate is submerged water flows over the upper apron (Figures 2 and 3).

Pier: Concrete piers support the roller gate racks on both driven and non-driven ends. The roller gate operating equipment is housed in the pier (Figures 2, 5, 7, and 8).

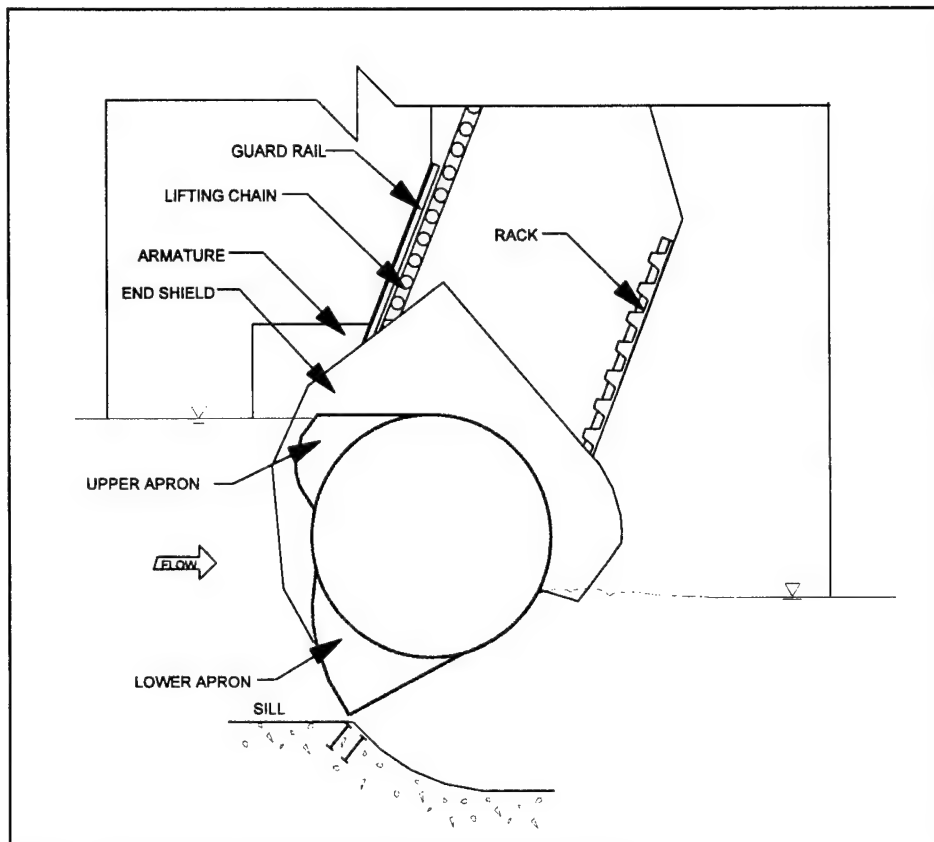
Figure 3. Roller dam gate (double-apron submersible gate)

Lower apron: The lower apron is the noncylindrical portion of the gate that prevents flow under the roller gate (Figures 3 through 6).

Rack: The rack transfers load from the gate to the pier utilizing rack teeth and a rack track similar to the rim teeth and rim track. The sloping rack is supported by a ledge in the pier (Figures 3, 4, 5, 8, and 9).

Guard rail: Located on the upstream portion of the pier, the guard rail is a matching surface for the rim track. The guard rail does not have teeth like the rack and the rim (Figures 3, 4, 7, 8, and 9).

Armature: The armature is the steel plate fastened to the pier upstream of the gate. Side seals fastened to the end shields contact the armature (Figures 3, 4, 7, and 8). **Side seals:** Side seals are fastened to the end shields and help prevent flow between the gate and the pier. Side seals may be constructed of timber or rubber (Figures 7 and 8).

End shield: The end shield prevents debris from collecting between the roller gate end drum and the pier (Figures 3, 4, 5, 7, and 8).

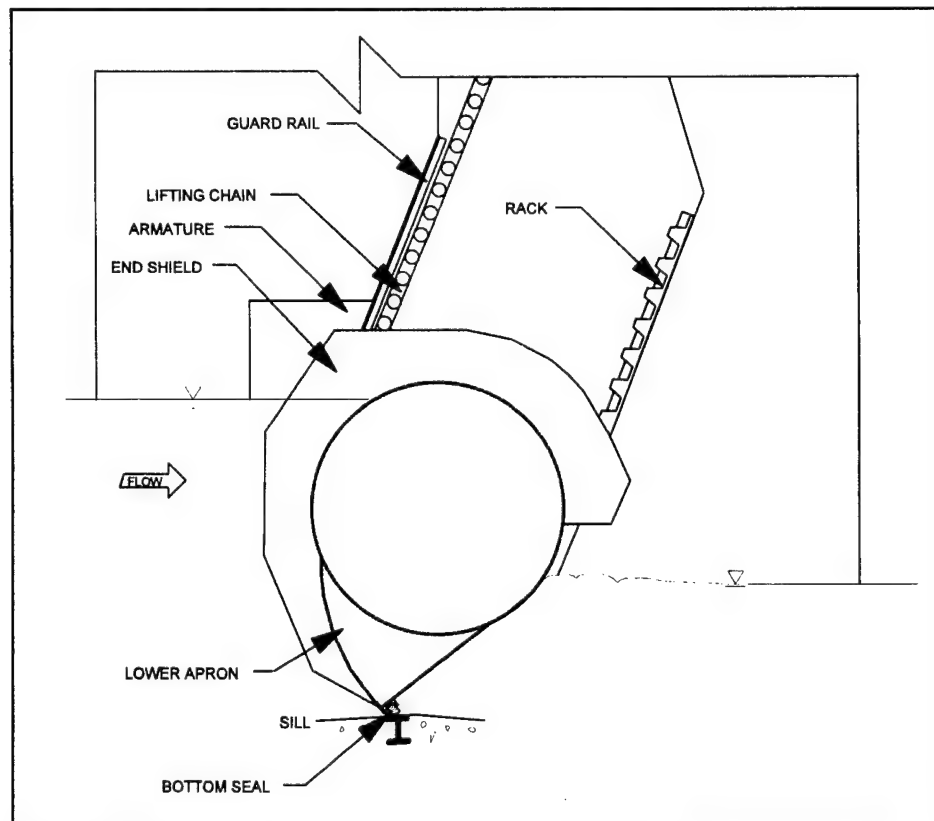
Figure 4. Roller dam gate (single-apron nonsubmersible gate)

Bottom seal: The bottom seal is the interface between the lower apron and the concrete sill (Figures 4 and 6).

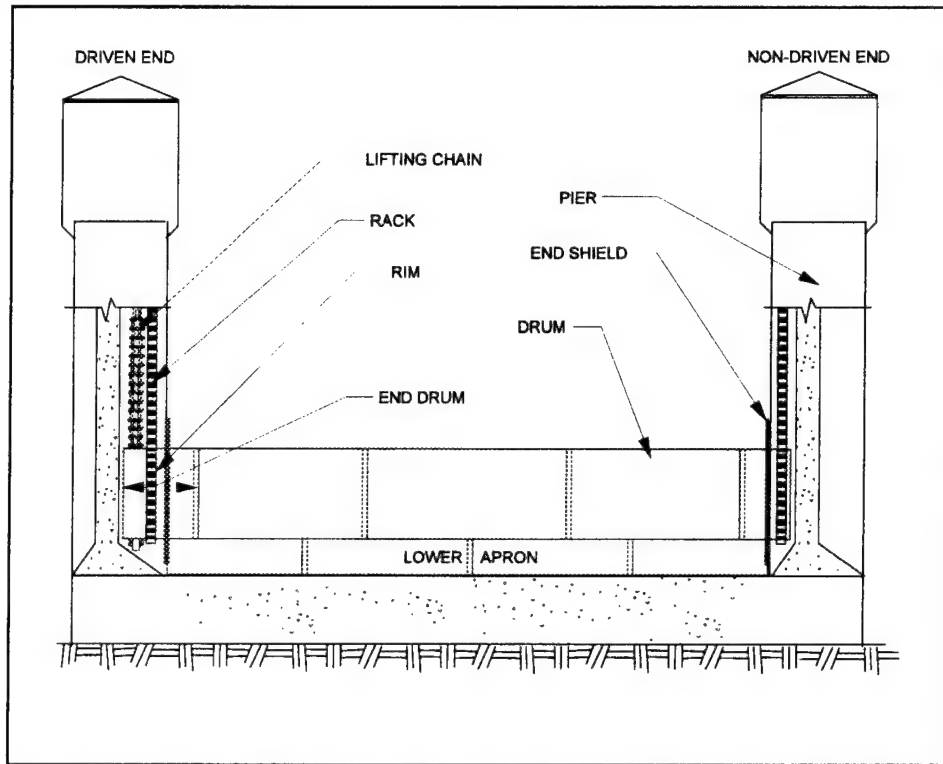
Figure 5. Roller dam gate (single-apron nonsubmersible, all parts except lifting chain common to both ends)

Drum: The cylindrical portion of the gate between the end drums of the driven and nondriven end is the drum, which is composed of several curved steel plates fastened together (Figure 5).

End drum: The end drum is the portion of the gate between the end disc and the first circumferential splice in the skin plate. In practice, it is more common to refer to the portion of the gate from the end disc to the load disc as the end drum (Figures 5, 7, and 8).

Rim: The rim is part of the gate and has a rim track and rim teeth that transfer load from the load disc to the rack track and rack teeth, respectively (Figures 5, 7, 8, and 9).

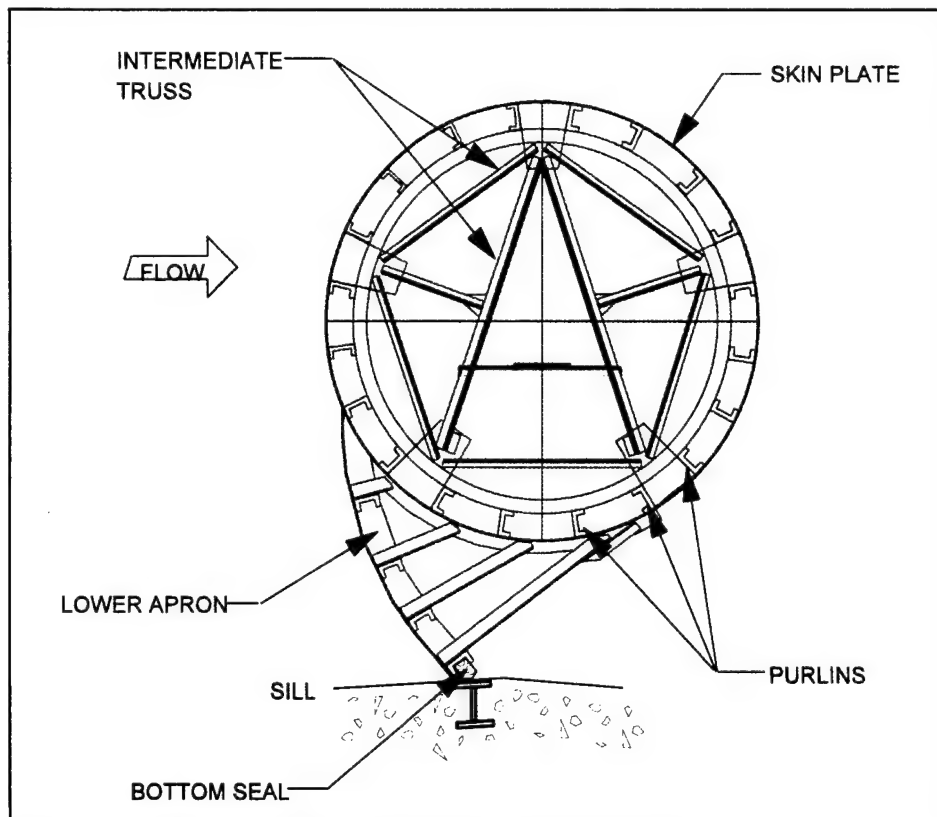
Figure 6. Section through drum (single-apron nonsubmersible)

Skin plate: The plate-steel that covers the cylindrical drum, end drums, and the apron(s) of the roller gate providing stiffness to the structure as it dams the water and transfers load to the internal framing (Figures 6 and 7).

Purlins: Purlins frame the gate longitudinally, supporting the drum skin plate. Purlins span between the internal trusses (Figure 6).

Intermediate truss: Internal trusses support the purlins bracing the roller gate transversely (Figure 6).

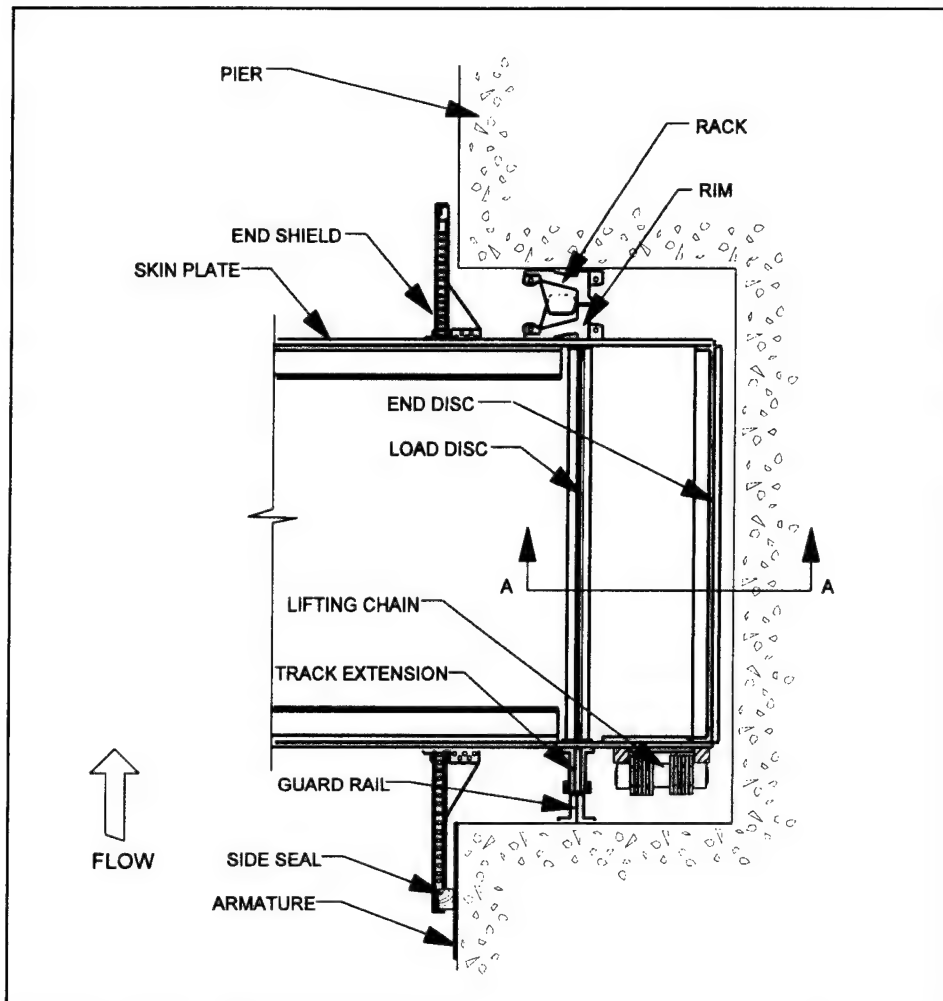
Figure 7a. Section of the driven end drum.

End disc: The end disc encloses the cylindrical end drum, there is one end disc on the driven end and one on the nondriven end of the gate (Figures 7 and 8).

Load disc: The load disc is inside the end drum of the gate and transfers load from the internal framing of the gate to the rim. Both ends of the roller gate have a load disc (Figures 7, 8, and 9).

Track extension: The track extension is a segmented casting that extends the rim track the complete circumference of the gate (Figures 7, 8, and 9).

Chain guides: These components are semicircular supports fastened to the gate that keep the lifting chain from contacting the skin plate (Figure 7).

Chain anchor: The lifting chain is connected to the chain anchor. Most of the chain anchor is visible from the exterior of the roller gate (Figure 7).

Chain anchor segment: The chain anchor segment is in the end drum of the driven end of the gate and connects the chain anchor to the gate, transferring the lifting force from the chain to the gate using a steel web plate (Figure 7).

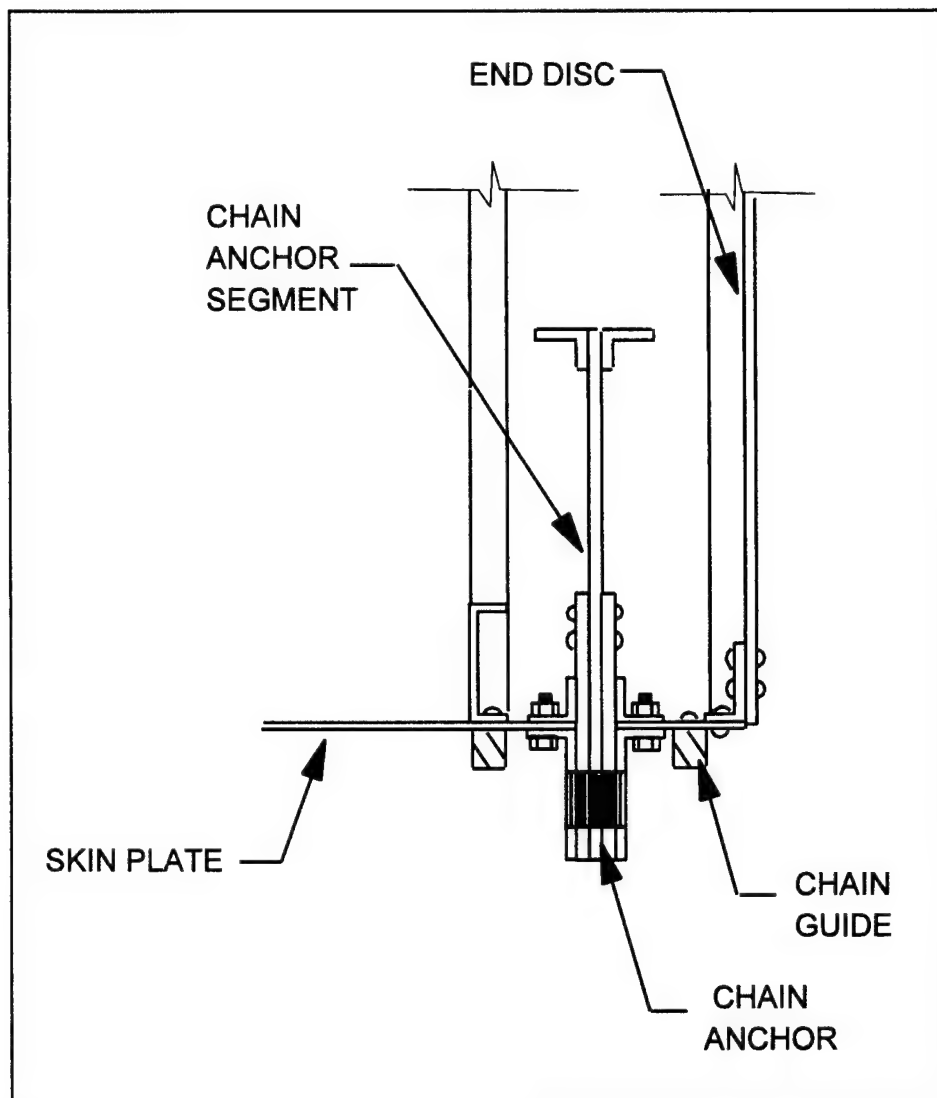
Figure 7b. Section A-A through driven end drum

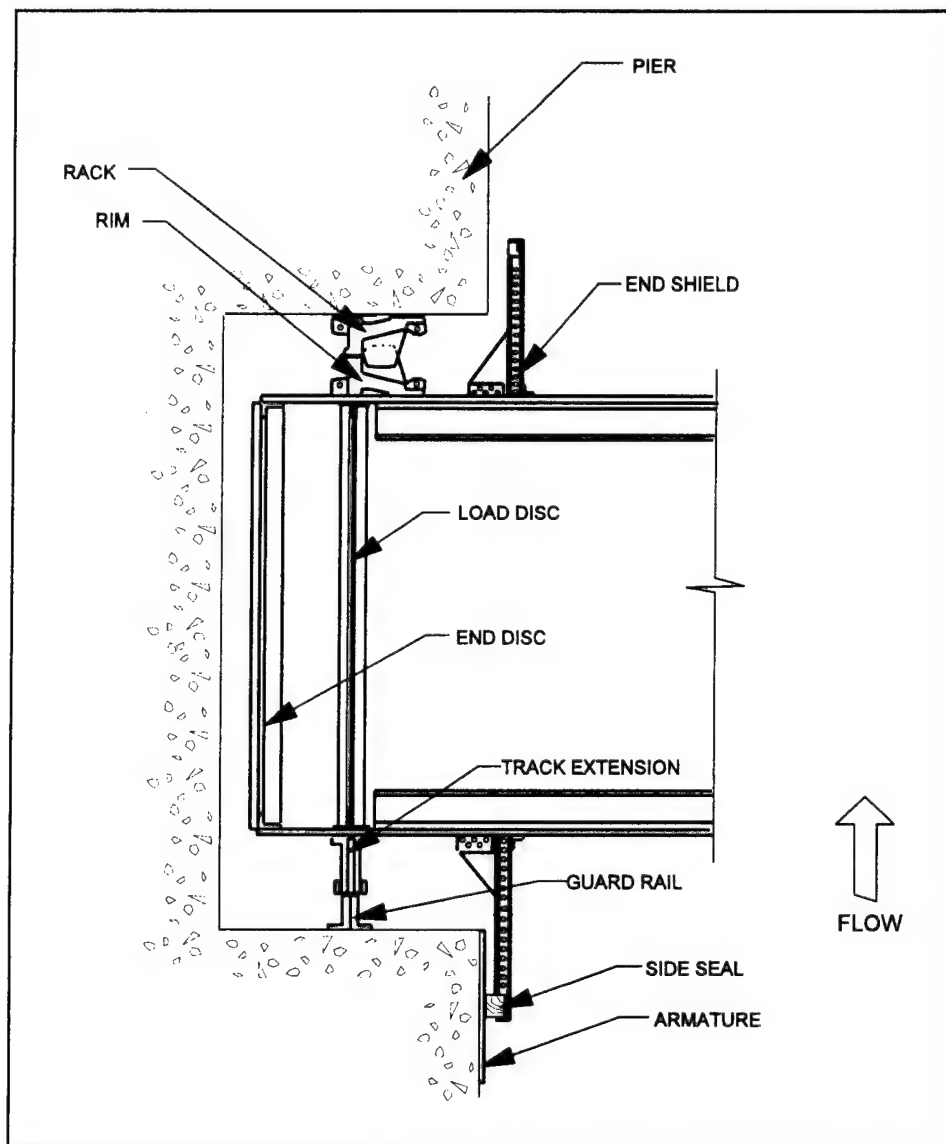
Figure 8. Section of the nondriven end drum

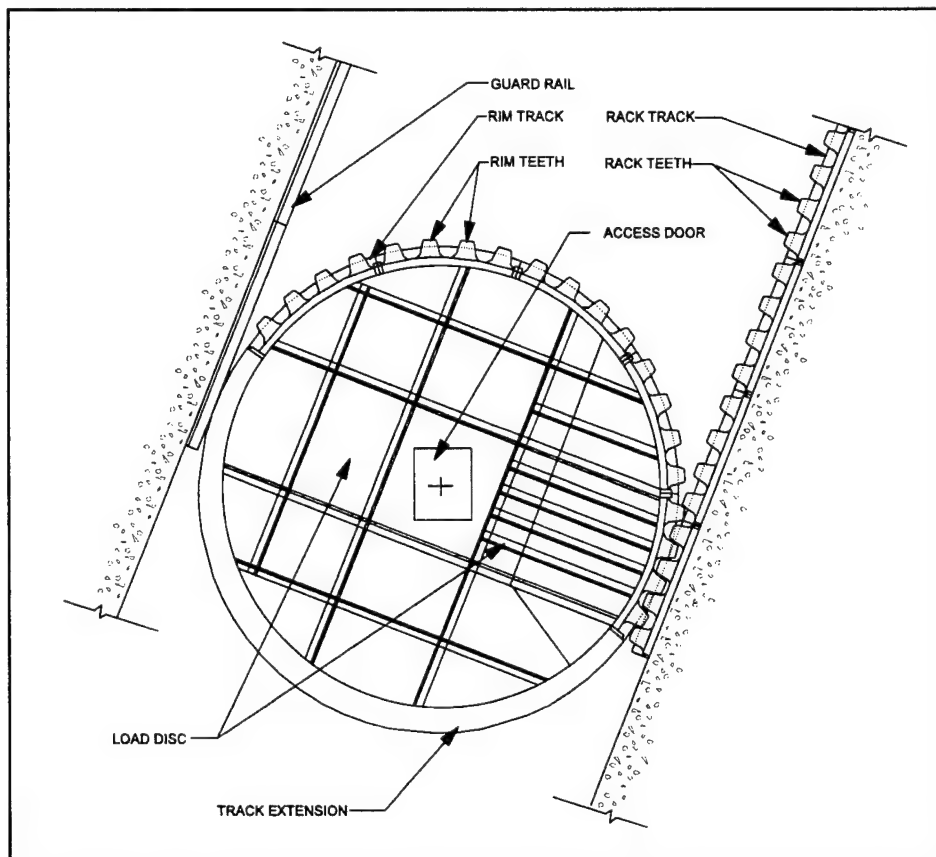
Figure 9. Load disc

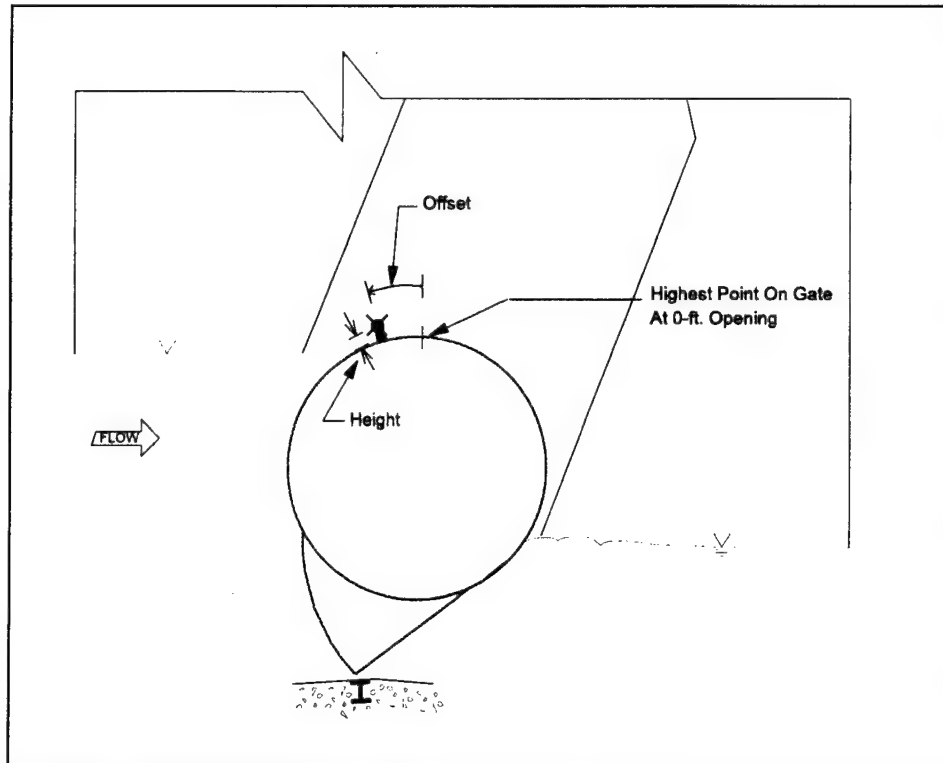
Figure 10. Start point for torsional misalignment measurement

TORSIONAL MISALIGNMENT: With the gate in the CLOSED position (chain still tight for a nonsubmersible gate), securely fasten projection devices to both end drums as near to the pier walls as possible. The devices should be placed upstream of the high point. They should also avoid obstructions such as the access ladder or recess in concrete pier on both ends of the gate. Project a mark onto the pier wall (Figure 10). Find the high point of the end drum with a level and measure the OFFSET from the high point to the projection device. It is imperative that the OFFSET DISTANCE be the same (within 1/8 in.) on both ends. It is also desirable to have the projection device positioned in the same place for subsequent inspections. Record the HEIGHT the projection device stands above the end drum skin plate. Again it is imperative that the HEIGHT OFF the GATE is the same (within 1/16-in.) on both ends. It is also desirable to keep the HEIGHT the same for subsequent inspections. Raise the gate to the 6-ft open position (Figure 11). Project another mark on the pier wall. At 6-ft open, the projection device should be downstream of the high point of the gate. Best results are obtained if the device is approximately 2-ft circumferentially from high point with the gate at 6-ft open. Next record the DISTANCE BETWEEN the 6-ft OPEN AND the CLOSED MARKS on both ends of the gate (Figure 12). Measurements should be made to the nearest 1/16 in.

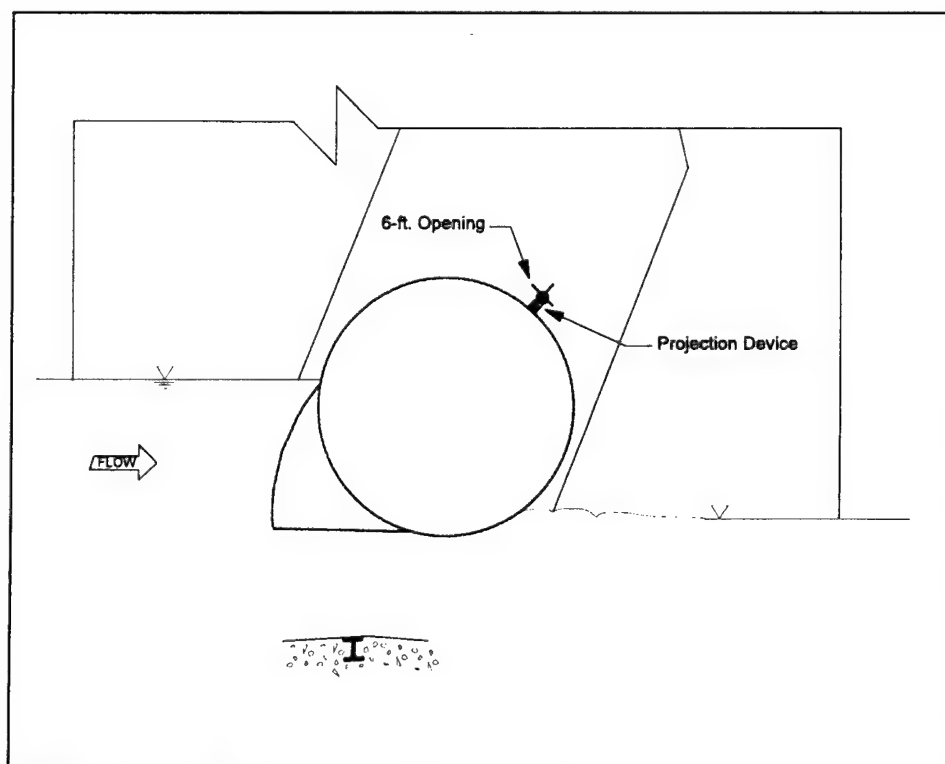
Figure 11. Second point for torsional misalignment

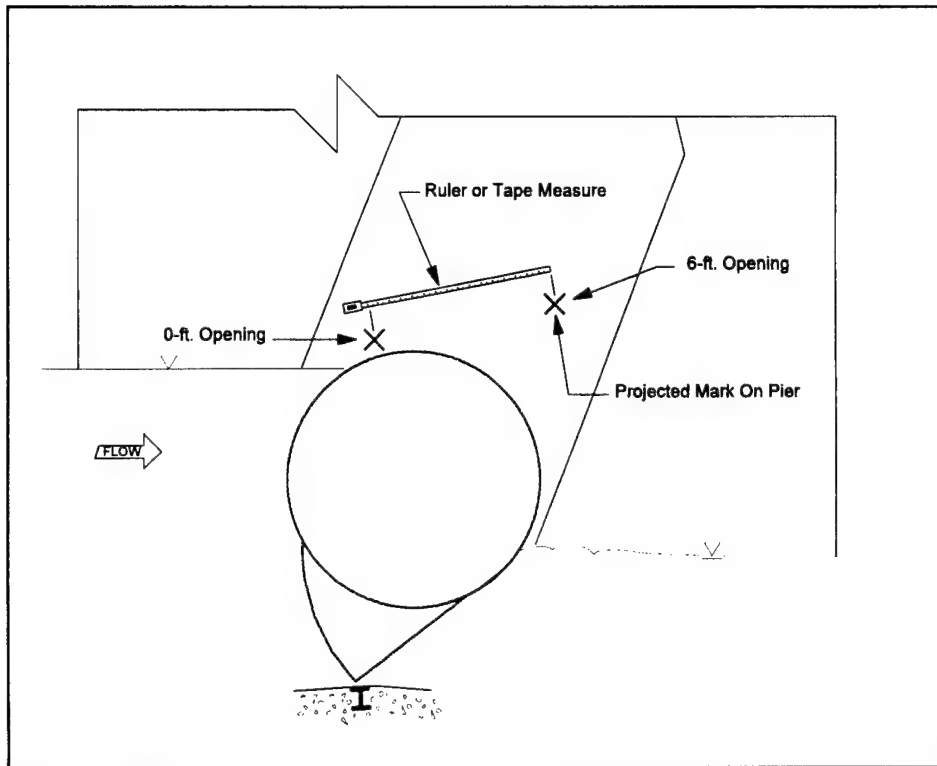
Figure 12. Measurement of torsional misalignment

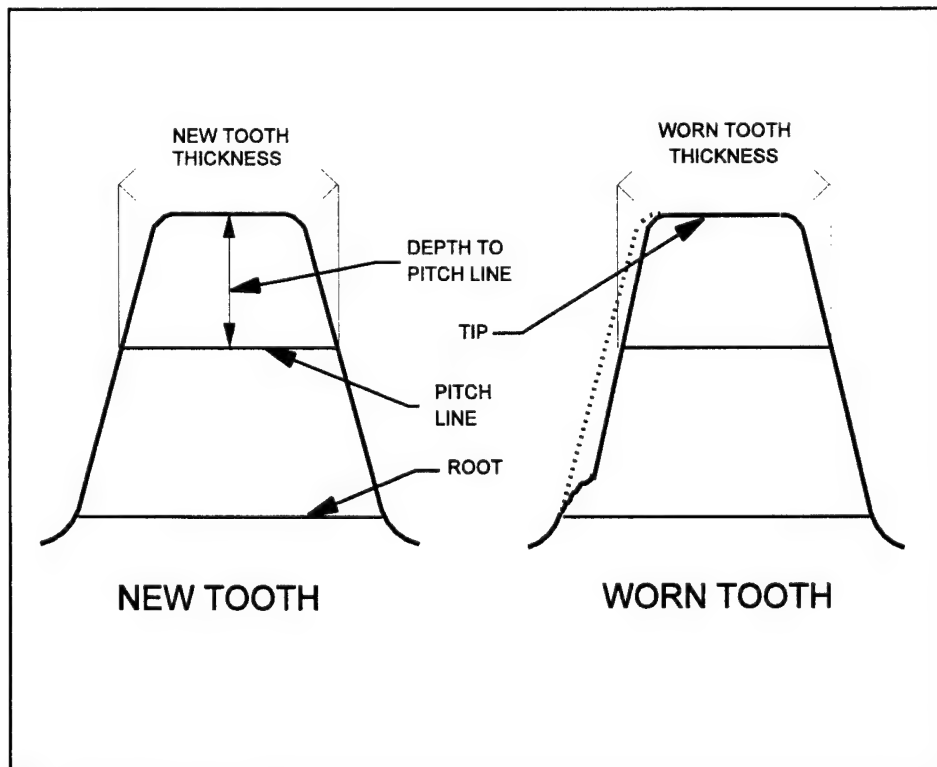
Figure 13. Tooth wear

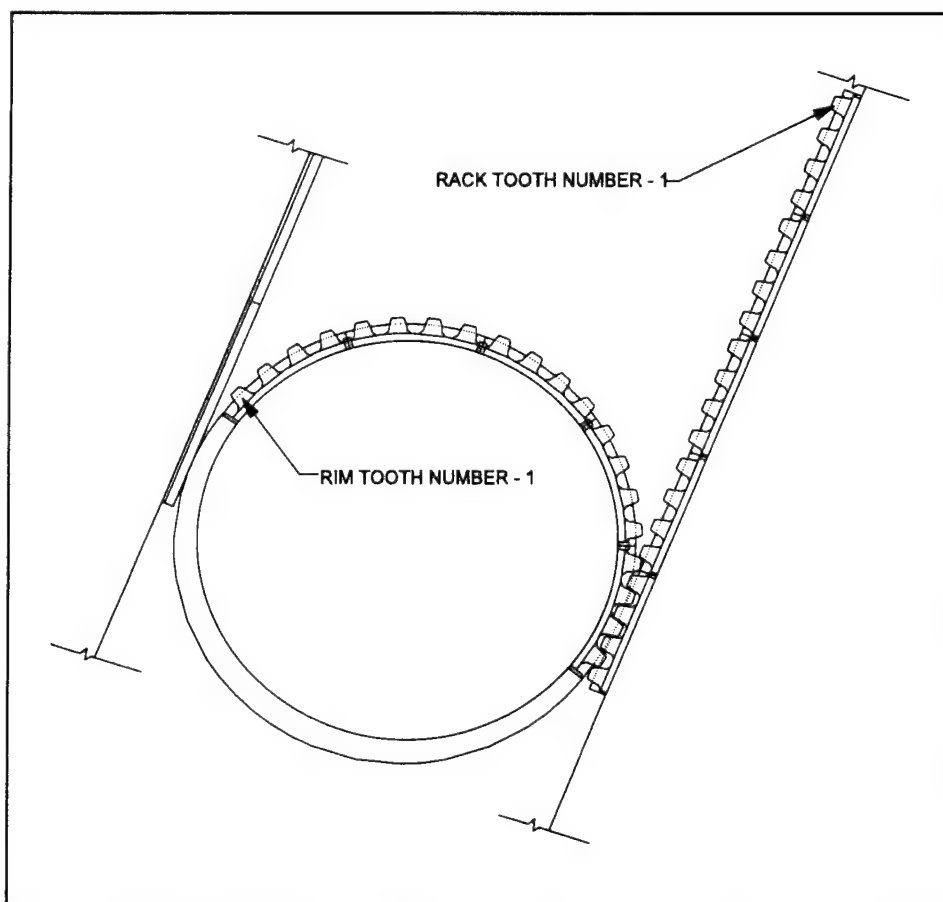
Figure 14. Tooth numbering convention

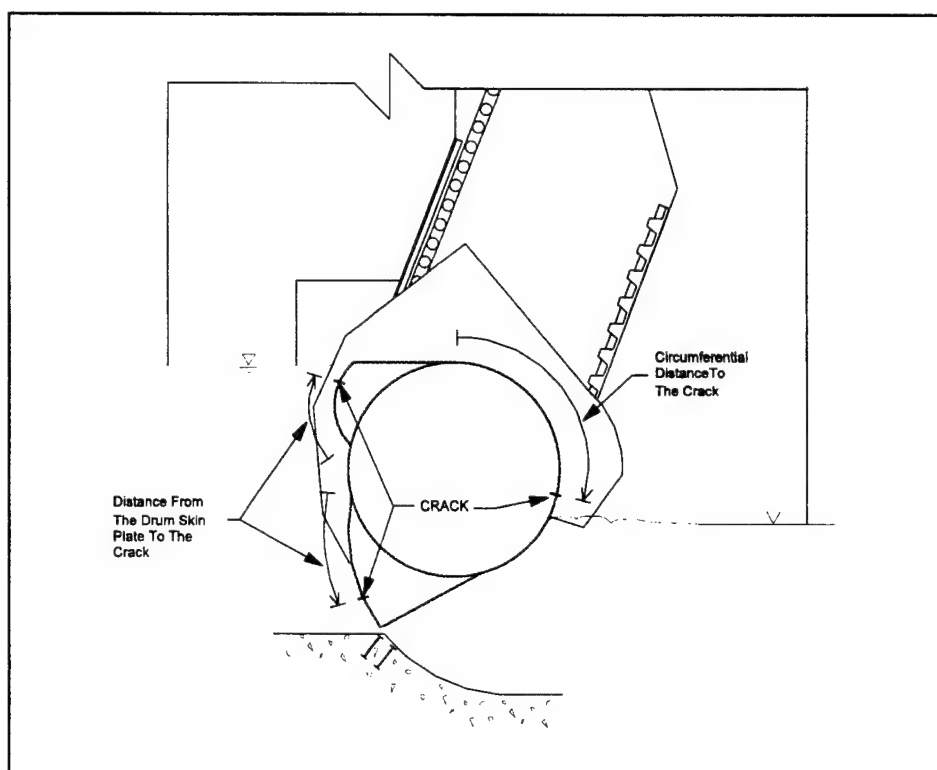
Figure 15. Convention for recording crack locations

CRACKS: List requested information for any COMPONENTS with cracks. Specifically record the LENGTH, and LOCATION of any cracks on the DRUM SKIN PLATE, a transverse crack in the DOWNSTREAM CENTER 1/3 of the DRUM, END DISC, CHAIN ANCHOR, UPPER APRON, LOWER APRON, and END SHIELD. All measurements are made with a ruler or tape measure. Record the LOCATION of cracks in the skin plate as the distance from the driven end of the gate. Record the location of any cracks as driven end or non-driven end if they are on the end disc or end shield. For cracks in the drum, record the circumferential distance to the crack. Use the following convention (Figure 15): when the gate is in the closed position, approximate the circumferential distance from the highest point of the skin plate to the crack. Revolve the tape measure about the gate and into the lower pool first. For a crack in the chain anchor, record the radial distance out from the end drum skin plate. For cracks in the aprons, record the distance from the driven end of the gate. Also record the distance from the point where apron and drum skin plates are in contact (Figure 15).

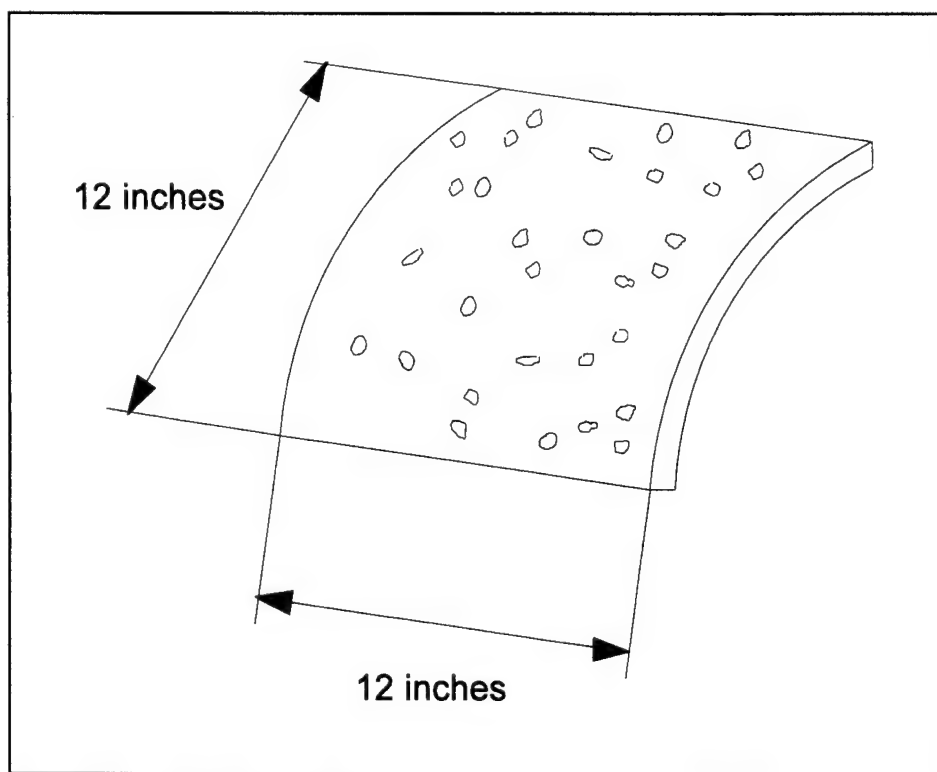
Figure 16. Corrosion measurement

CORROSION: A 1-sq-ft area of corrosion or erosion is selected on each COMPONENT (Figure 16) to characterize the maximum density of corrosion or erosion. For each component, indicate if corrosion (C) or erosion (E) caused the material loss. Estimate or check drawings for the original section thickness (SECT THICK) of each component. It is likely that the skin plate thickness varies from one end of the gate to the other. Therefore, record a section thickness that corresponds to the plate thickness in the region with the most severe corrosion. When looking for the region with the most severe corrosion, pay particular attention to the splash zones. The maximum pitting depth (MAX. DEPTH) is recorded in column 3. For the 1 sq ft, the average pitting depth (AVG DEPTH) is also recorded. Deterioration can be measured in one of two ways. For the selected area, record either the percentage of the area (% AREA) that is pitted or count the actual number of representative pits (NO. PITS). If the data was entered by counting the number of pits, record the average diameter (AVG DIA) of the representative pits in the last column. In some cases, when the percentage area method is used and the deterioration is uniform, the percentage of area affected could be 100 percent and the average pitting depth is the average thickness reduction.

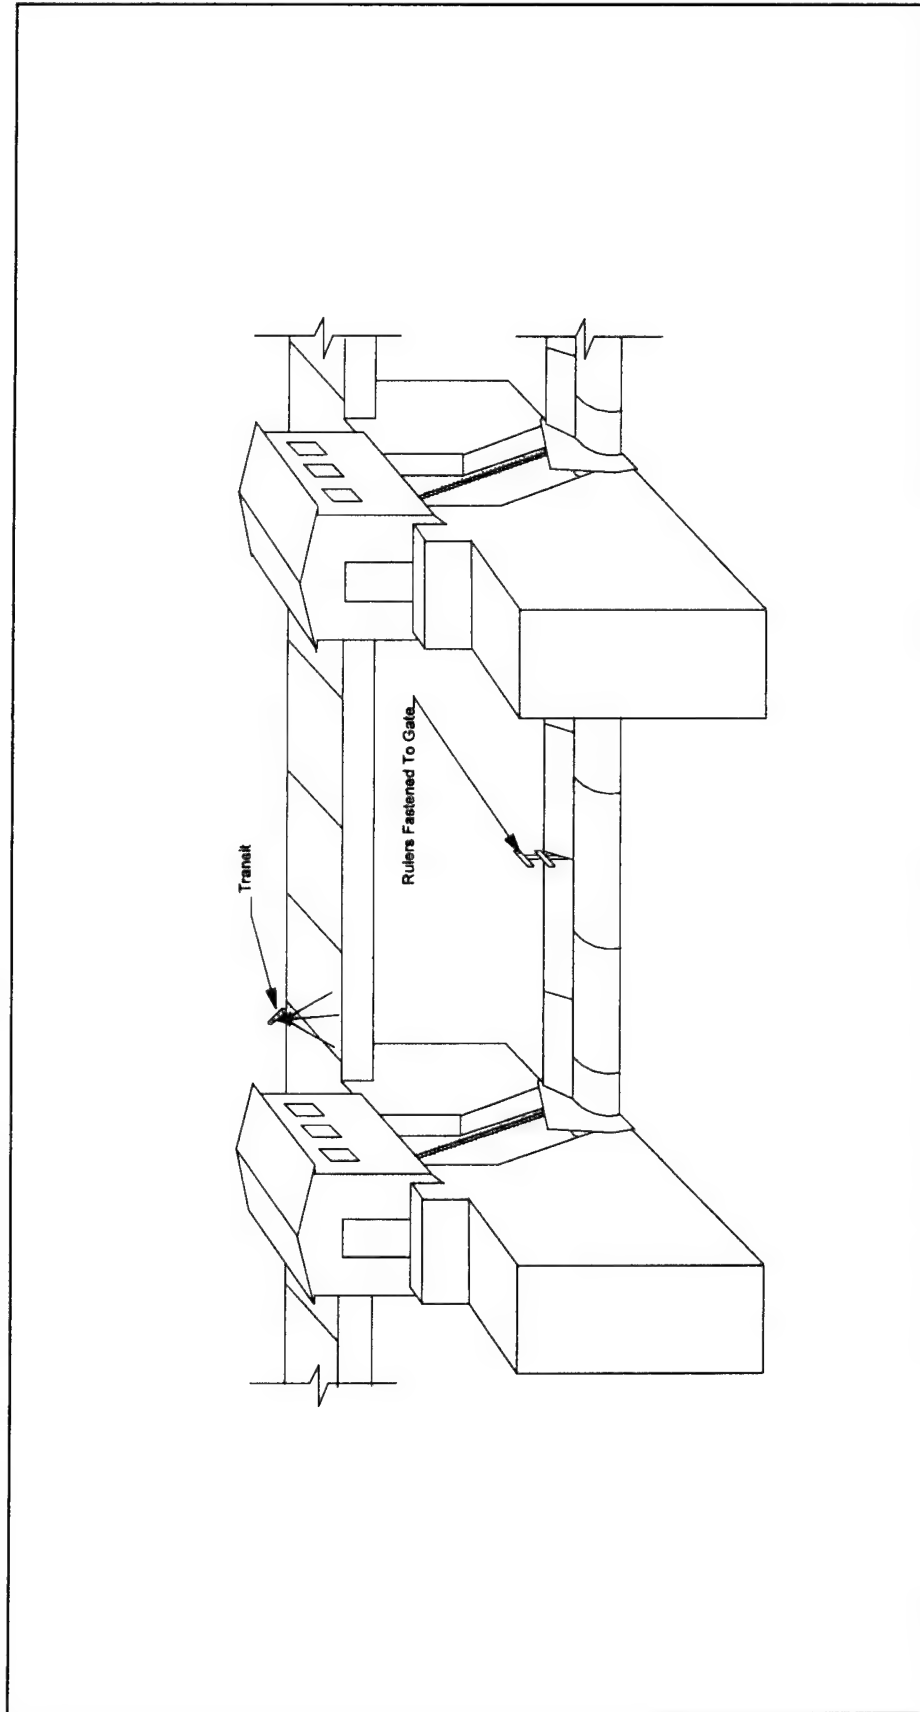
Figure 17. Downstream deflection measurement technique with transit on pier

DOWNSTREAM DEFLECTION: Place transit on pier so the center of the gate can be viewed through the eye piece. Level the transit. Fasten two HORIZONTAL RULERS to the middle of the gate separated by approximately 3 ft vertically. Orient the RULERS so that the 12-in. mark is downstream. Also fasten a VERTICAL RULER to the middle of the gate. Orient the VERTICAL RULER so the 12-in. mark is down. The group of rulers must be positioned on the vertical centerline of the drum (Figure 17). To read all three rulers with only one transit, use the following technique. Ensure that the transit cannot rotate from side to side by locking the horizontal rotation of the transit. Keep it locked for the entire procedure. First, read the TOP HORIZONTAL RULER under the NO HEAD condition. Record the reading in the first blank under NO HEAD. Second, rotate transit scope vertically to the lower ruler and then lock it in that position. Record the reading on the BOTTOM HORIZONTAL RULER in the second blank of the NO HEAD measurements. Also read and record (in the third blank under NO HEAD) the measurement on the VERTICAL RULER. Next remove the bulkheading, fully loading the gate. Read the BOTTOM HORIZONTAL and VERTICAL RULERS, and record the readings in the FULL HEAD COLUMN in the second and third blanks. Unlock the transit scope vertically. Rotate the scope to view the TOP HORIZONTAL RULER. Record the reading in the first blank under FULL HEAD.

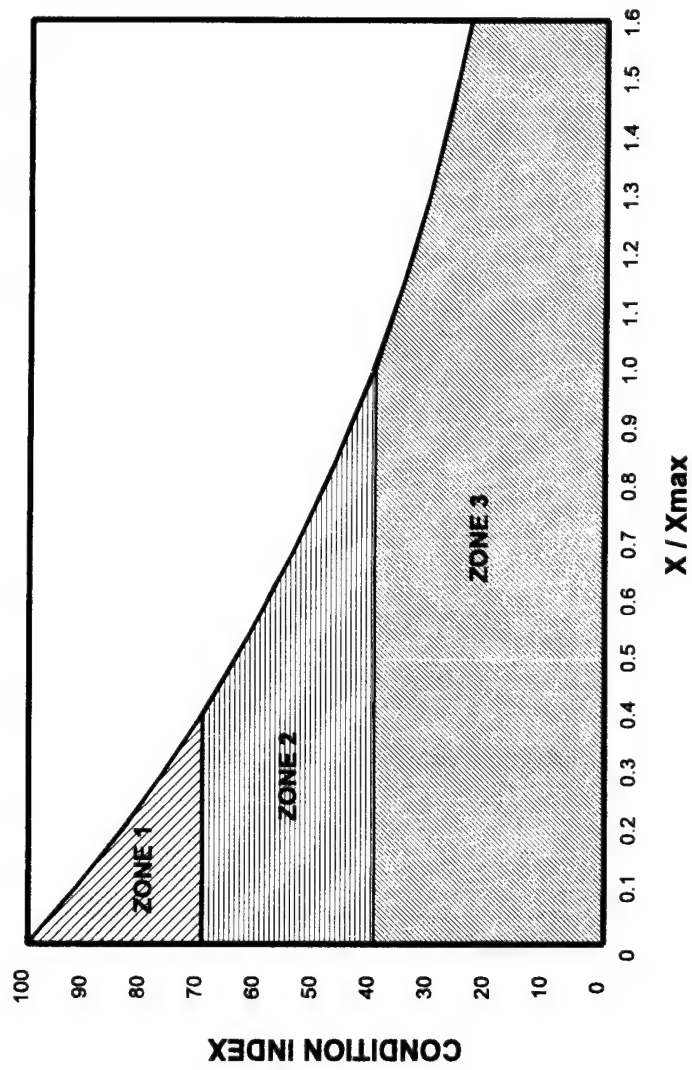
Figure 18. Condition index related to X/X_{max}

Figure 18 is a graph of X/X_{\max} versus the CI. Depending on the inspection conditions, each of the 10 distresses can be assessed to a greater or lesser degree. For example, for a complete inspection of the rim, the gate must be out of the river. If the gate is left in its normal operating condition, only a partial rim inspection is possible. Table 3 lists the distresses and notes the type of inspection that is possible given inspection conditions of: normal operation, out of operation, or bulkheaded (see **Overview of Inspection Procedure**, Chapter 2). Inspections are divided into three levels of detail: none, partial, or full inspection.

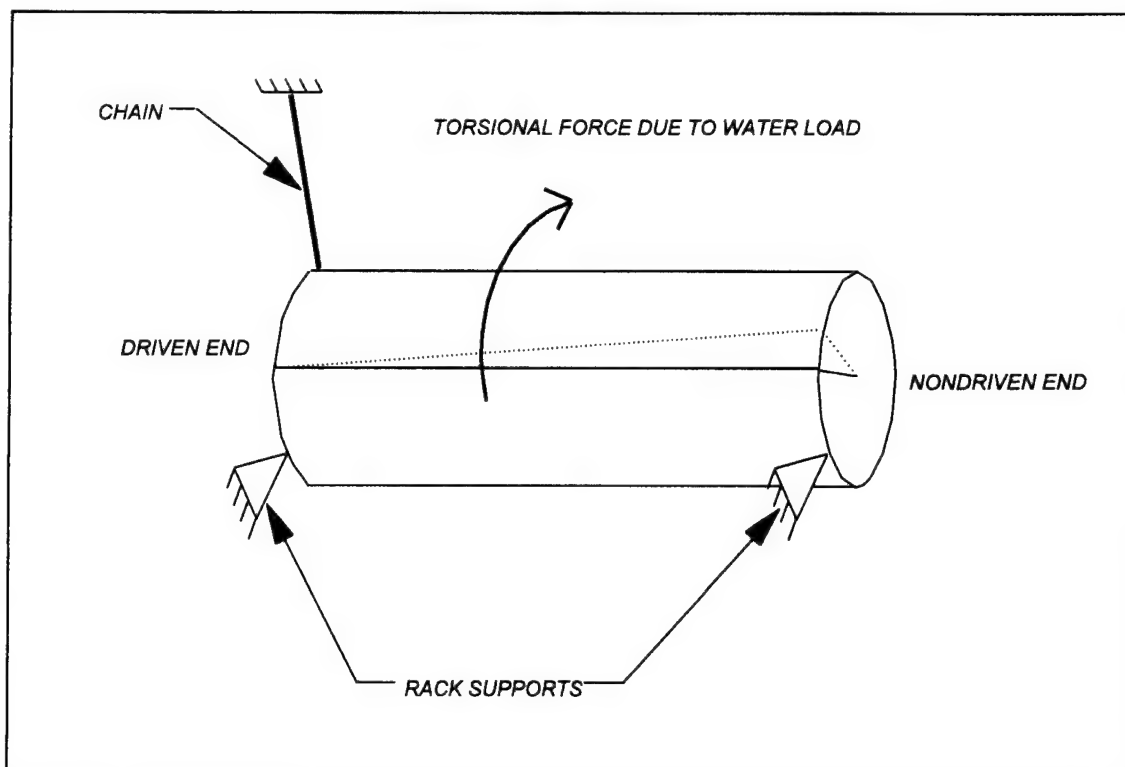
Figure 19. Torsional twist

Torsional misalignment is excessive twist in the roller gate due to the torsional forces acting on it (Figure 19). Possible causes of torsional misalignment are:

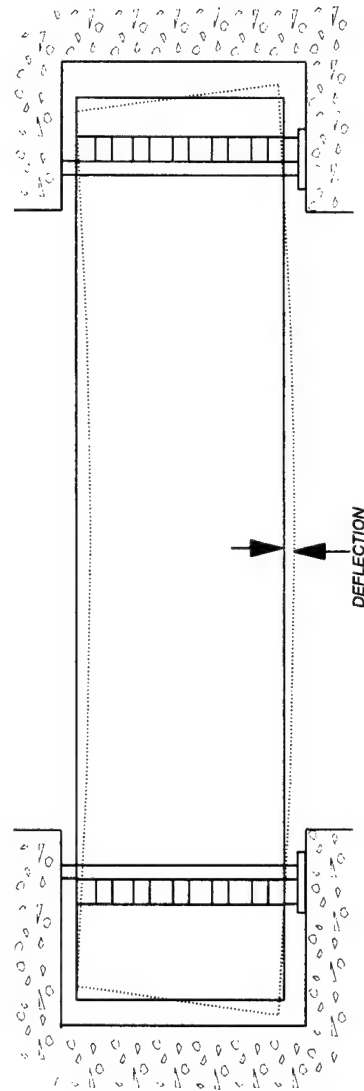
Figure 20. Deflected shape

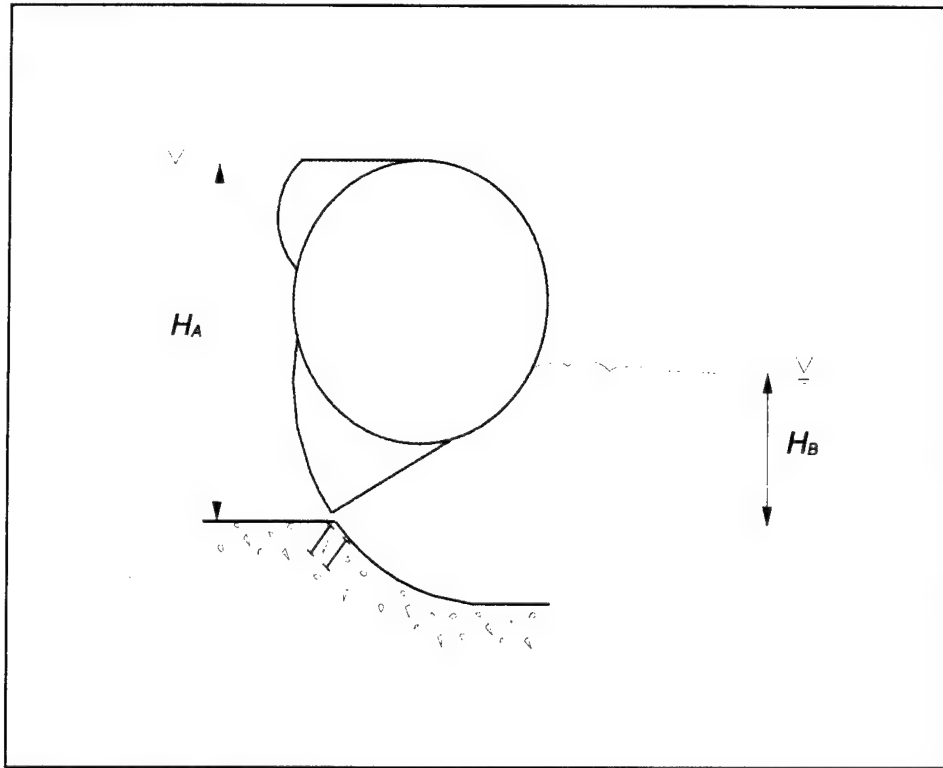
Figure 21. Head conditions

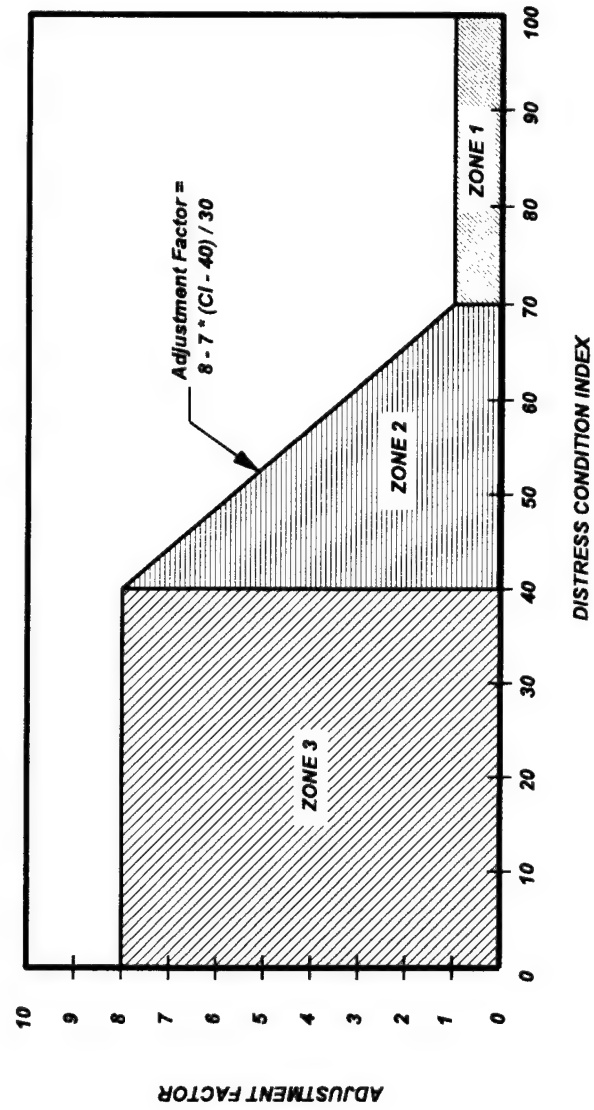
Figure 22. Weight adjustment factor for condition index

Therefore, relative initial weights are multiplied by a weight adjustment factor that depends on the CI. Figure 22 is a graph of the weight adjustment factor versus the individual distress CI. For CIs in Zone 1, the adjustment factor is 1.0 and

the relative initial weight listed in Table 6 is used. If the CI is in Zone 2, the weighting factor varies linearly from 1.0 at a CI of 70 to 8.0 at a CI of 40. If the CI is in Zone 3, the adjustment factor has a value of 8.0. This means that if the CI is 40 or less the relative initial weight is increased by eight times its original value given in Table 6. If any of the individual distresses calculates a CI in Zones 2 or 3, Equation 3.41 must be modified to be:
